Heat Resiliency at Sun Tran Bus Stops

Tucson, AZ

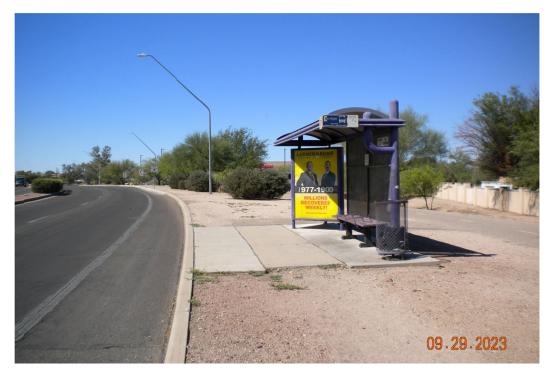
Purpose Figure 1: A Sheltered Sun Tran Bus Stop (Sept 2023)

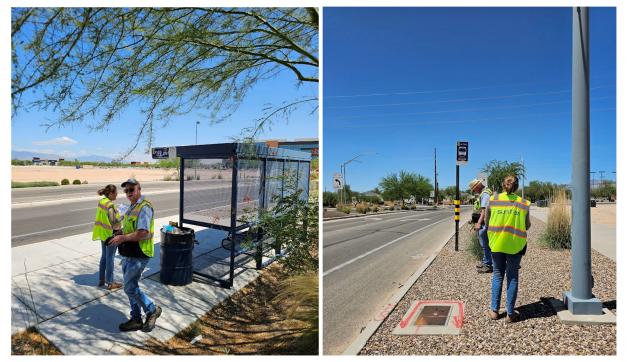
Figures 2 and 3: Sun Tran Staff Measures Temperatures at Bus Stops (Aug 2023)

During an Excessive Heat Warning on August 4, 2023, Sun Tran staff visited multiple bus stops throughout the City of Tucson and measured both ambient and ground temperatures. By gathering this temperature data at varying styles of bus stops, Sun Tran staff was able to identify the amenities that best mitigated heat. Bus stops that had vegetation nearby, not necessarily even providing shade, were found to have lower ambient air temperatures than the bus stops without any vegetation. The presence of a bus stop shelter alone notably reduced the ground temperature at the bus stops, but it was equally as effective in cooling the ambient air as vegetation. When both a bus stop shelter and nearby vegetation were present, the reduction in temperature was most significant.

Bus Stop Location	Bus Stop Description	Ground Temperature	Ambient Temperature	Time (AZ (GMT-7))
Martin Luther King Jr Way/36 th Street (SE)	No Shelter, No Vegetation, No Tree Shade	124°F	108°F	01:56 PM
Park Avenue/Tucson Marketplace (NE)	No Shelter With Nearby Vegetation	111°F	107°F	02:08 PM
6 th Avenue/29 th Street (NE)	Shelter with Tree Shade	108°F	107°F	01:20 PM
Martin Luther King Jr Way/Tucson Marketplace (NW)	Shelter with Nearby Vegetation	109°F	106°F	01:49 PM

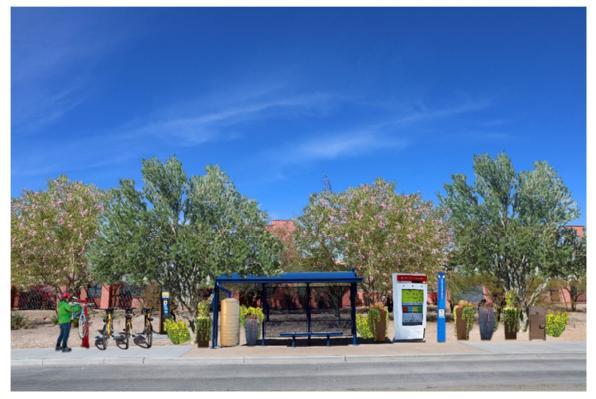
Figure 5: Digital Mock-Up of a potential Tier 3 Tucson Resilient Together Bus Stop

Six bus stops have been selected to receive Tucson Resilient Together improvements based on a tiered system. Tier 1 bus stops are planned to receive shelters, static information displays, benches, solar powered lighting, and a tamper-proof trash receptacle. Tier 2 bus stops will receive the same amenities as Tier 1, but also additional native vegetation, green stormwater infrastructure, a dynamic information kiosk, an emergency call button, and security cameras. Tier 3 bus stops will receive all the same amenities as Tier 2, but also a bike-share station.
