- 1 August 16, 2025**  
**Incident**  
Accident involving Streetcar 105 occurred. Repair program initiated.

- 9 August 2026**  
**Sun Link Streetcar 105 returns to the track today!**

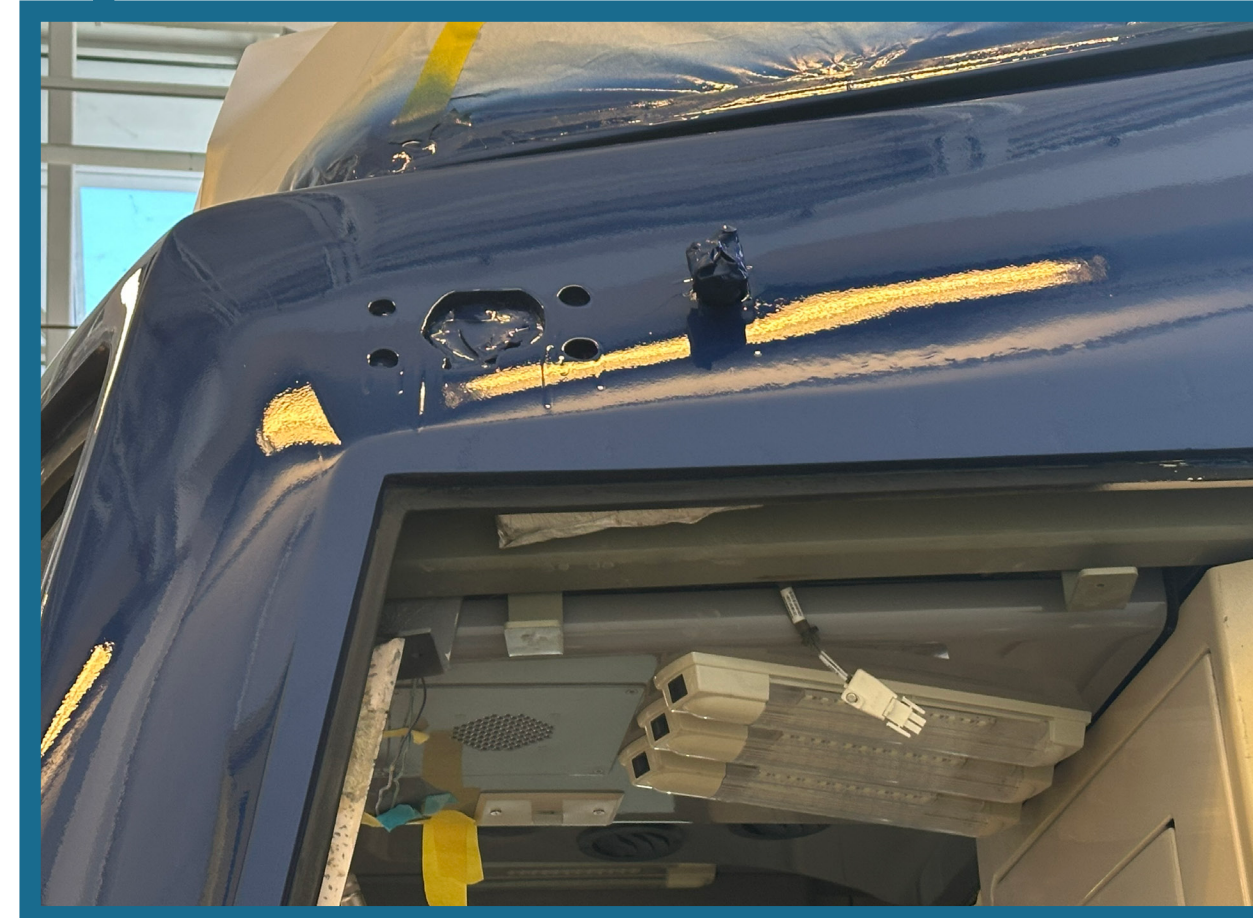
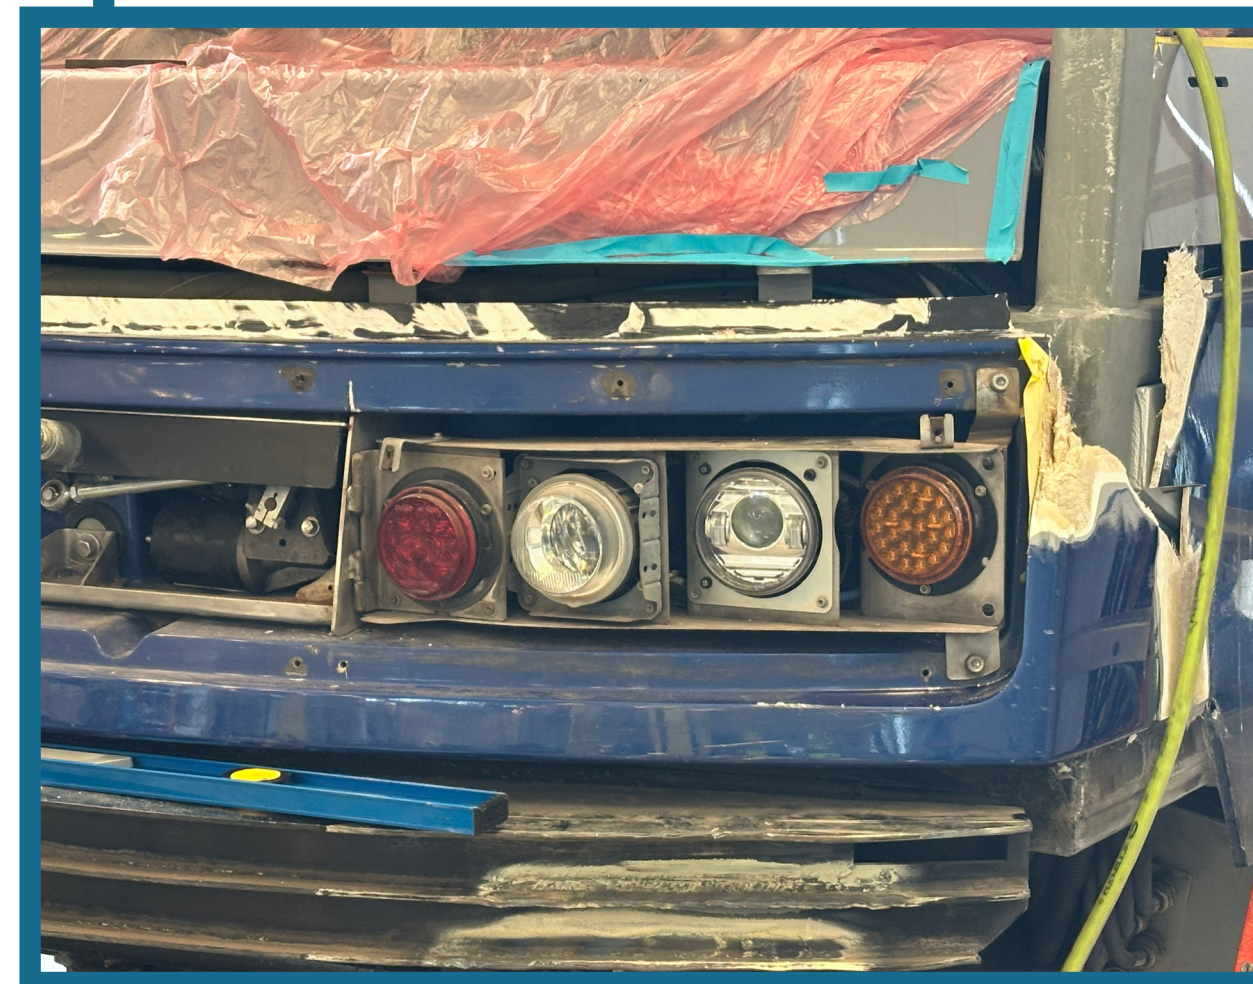
- 3 Nov. – Dec. 2025**  
**ADOT inspection of 105**

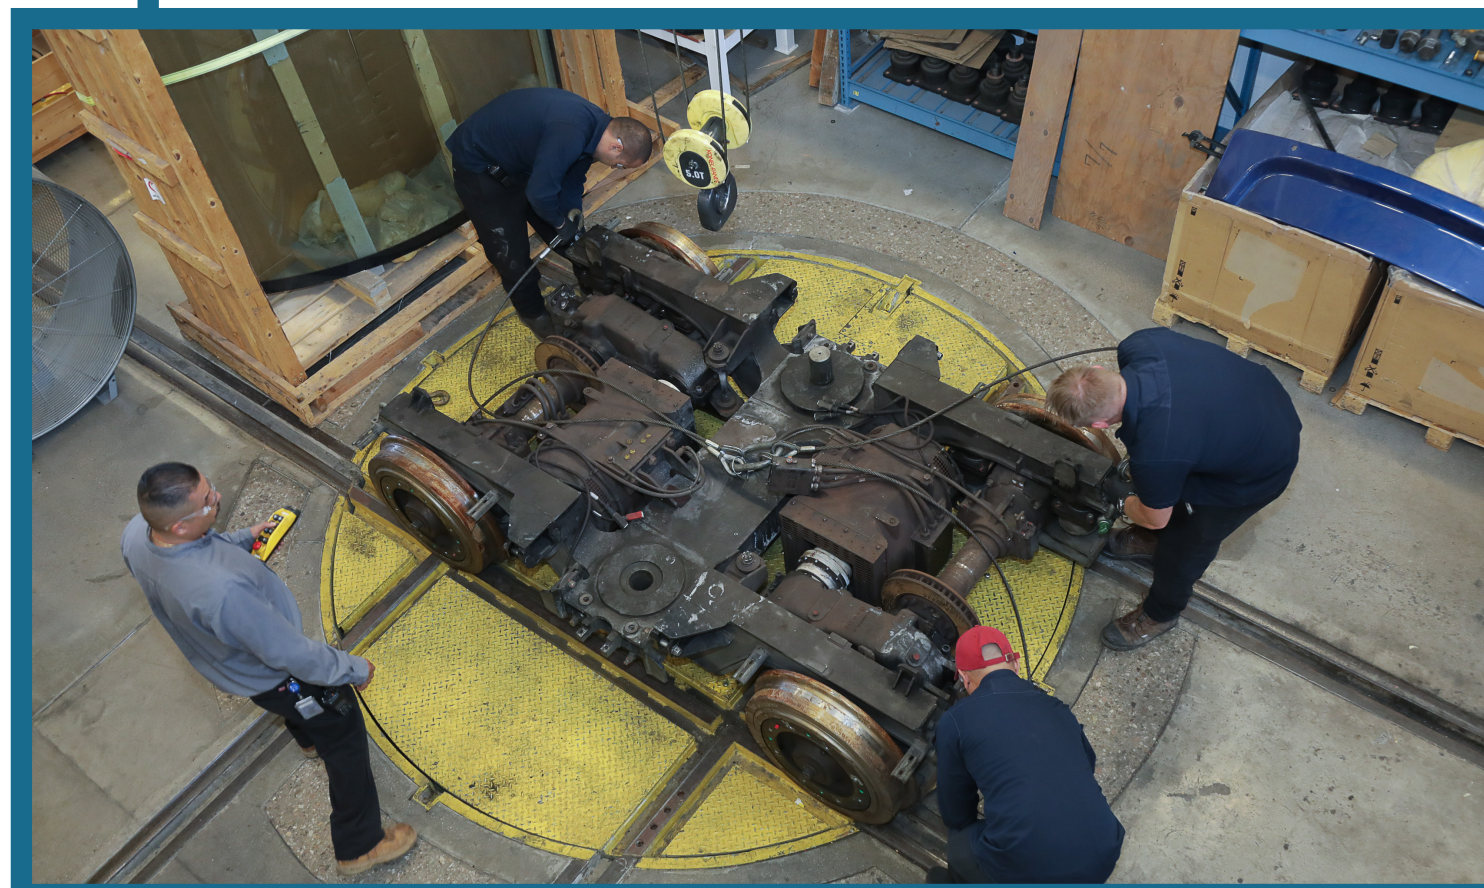
- 7 July 2026**  
**Hunting-condition investigation**  
Truck replacement, ride-height adjustment, suspension alignment, spring and shim inspection, damper replacement, and repeated operational testing to investigate the B-Cab hunting condition. 10,000-mile inspection performed per ADOT request. Investigation and corrective testing continued.

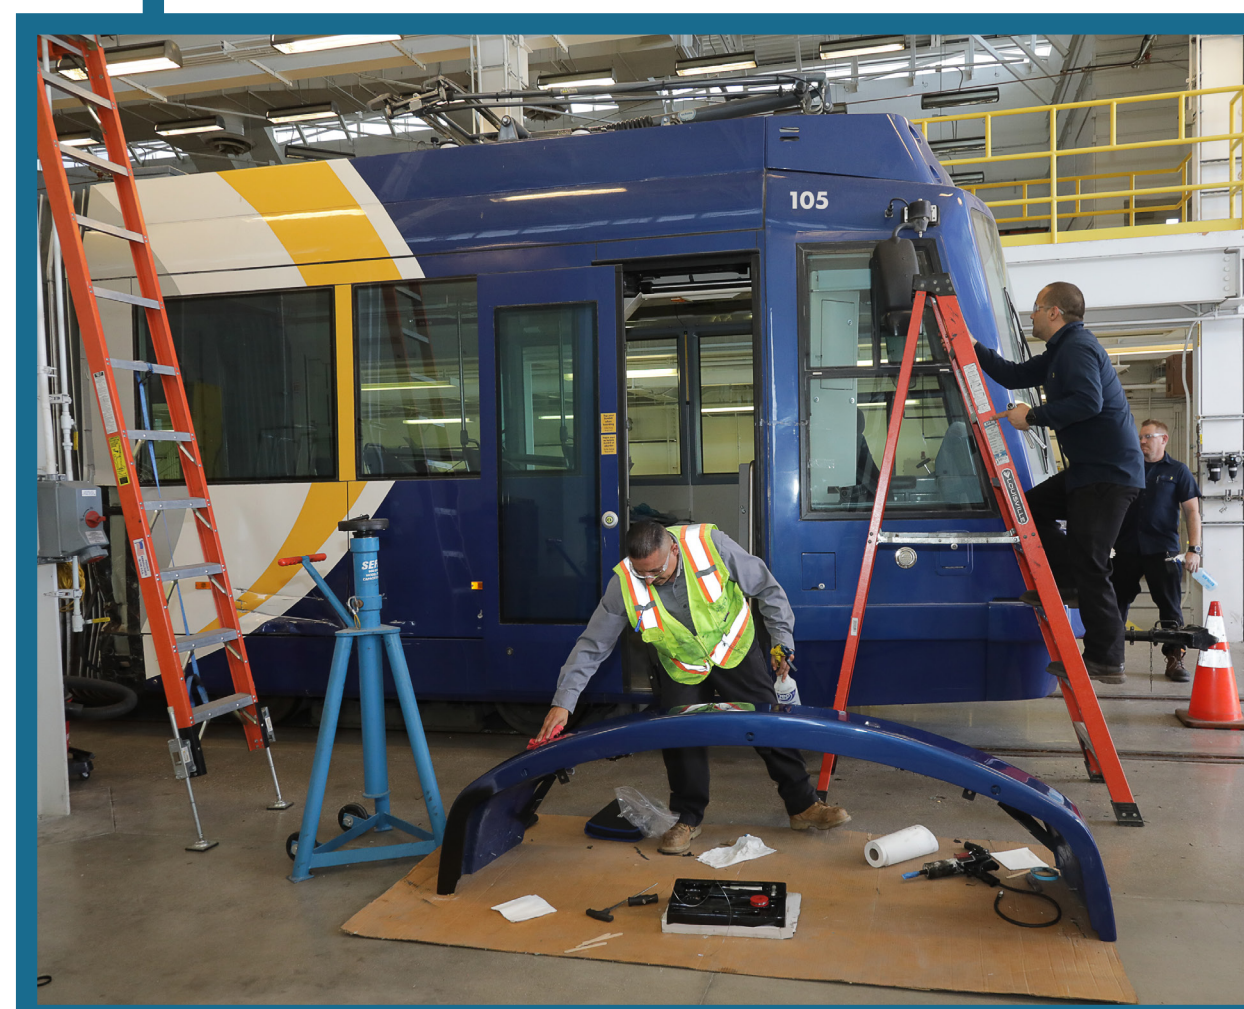
- 8 August 2026**  
**Testing and safety checks**  
All repairs and adjustments have been completed. The burn-in run prescribed by ADOT has also been successfully completed, and the streetcar is ready for service with no faults or issues noted. Ready for service.
